How to Change the Engine Mounts

By Steve Brookes

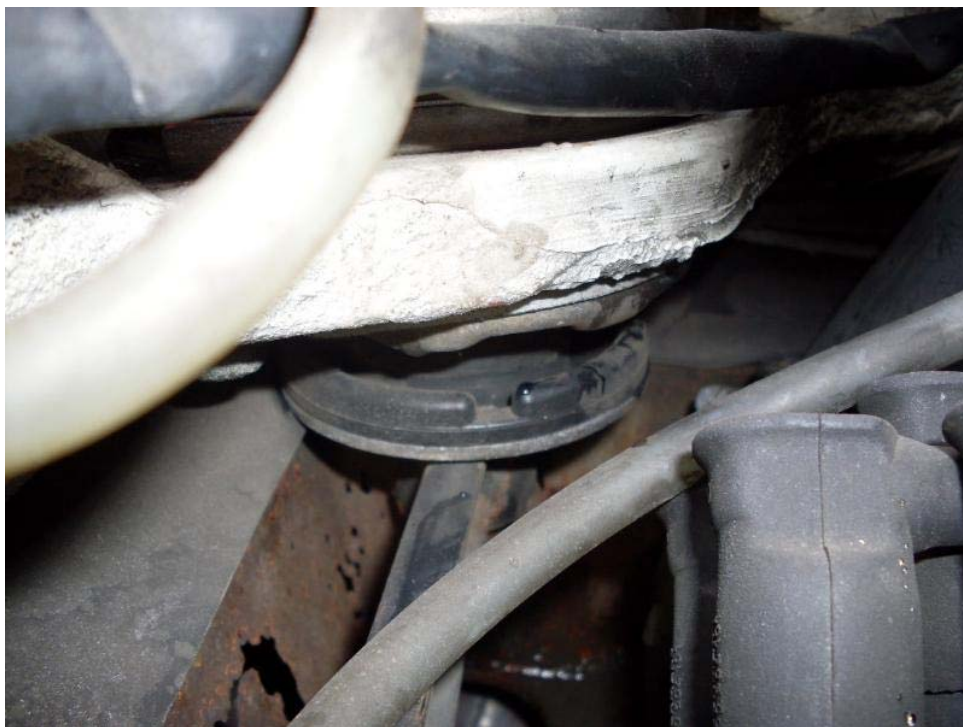
The left one was sagging a bit:

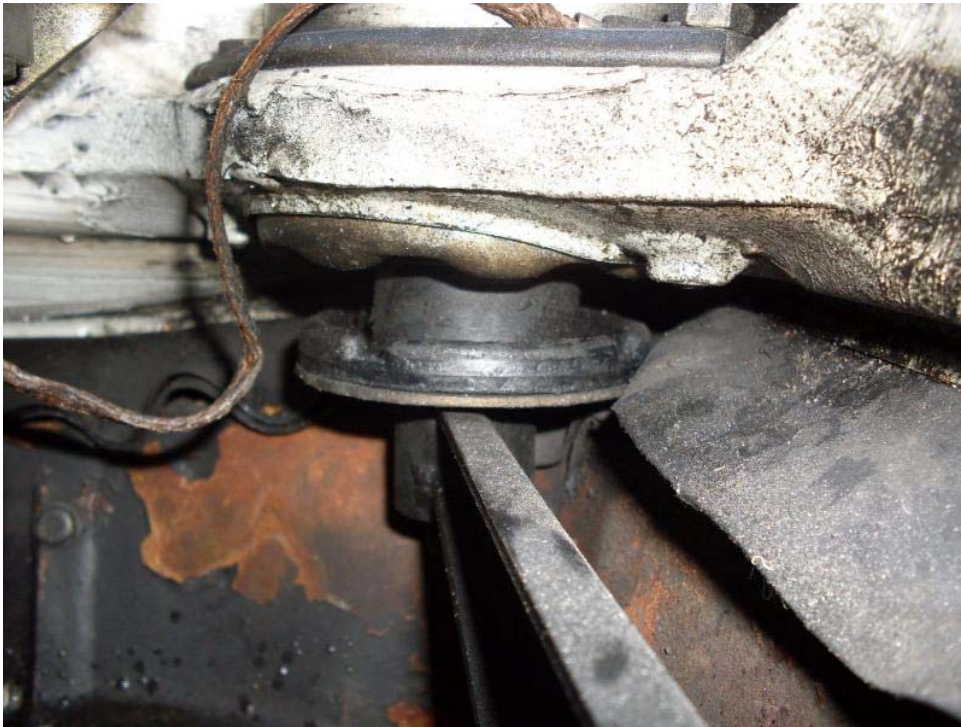
The right one was sagging a lot:

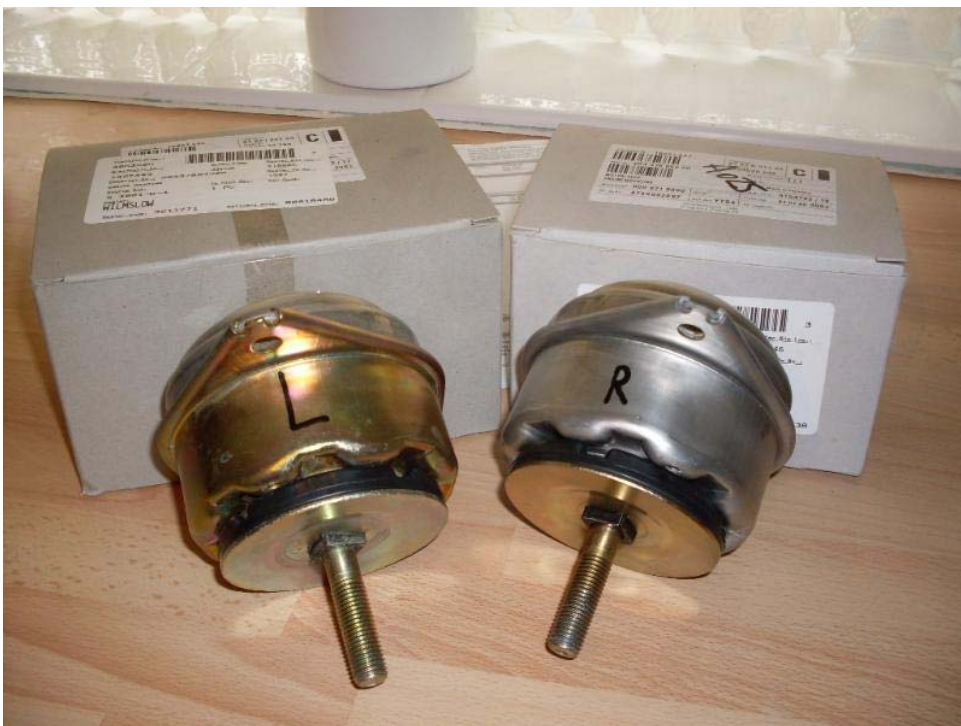
So I duly ordered new mounts from Porsche. The part number for the left one is 964 375 049 00 and 964 375 050 00 for the right one. Once out of the box the only way of telling them apart is that the factory has written L and R on them!

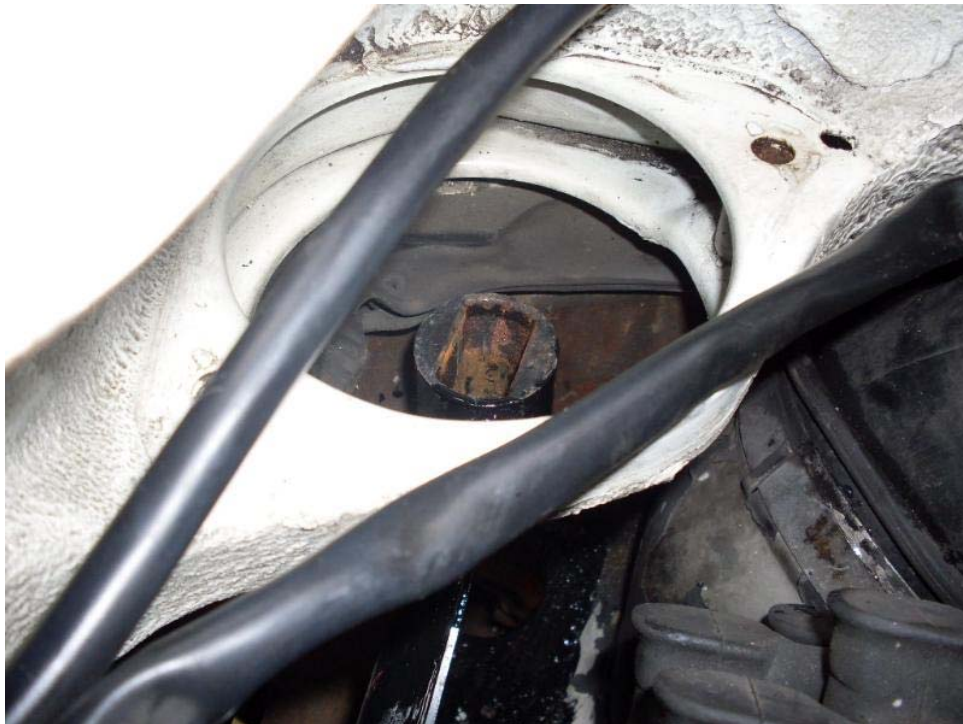
Here's a picture where the left mount has been removed:

1. Chock the front wheels. Jack up the engine to take up the strain (I simply jacked it up until it had taken up the slack of the sagging mounts). Rear wheels remain on the ground.
2. Undo the nut on the bottom of the mount. You'll need a 19 mm socket (I used a 6 sider which is much safer than the tooth type), long extension and a long socket wrench (it's very tight to undo). You access the nut from underneath (there's a hole in the heat shield so you can get to it).
3. Undo the two 13 mm bolts that secure the mount on the top and wiggle it out.
4. Insert new mount and fix it in place with the 13 mm bolts.
5. Put the nut on the bottom and tighten to 85 nm.
6. Do the other one (i.e. do one at a time)

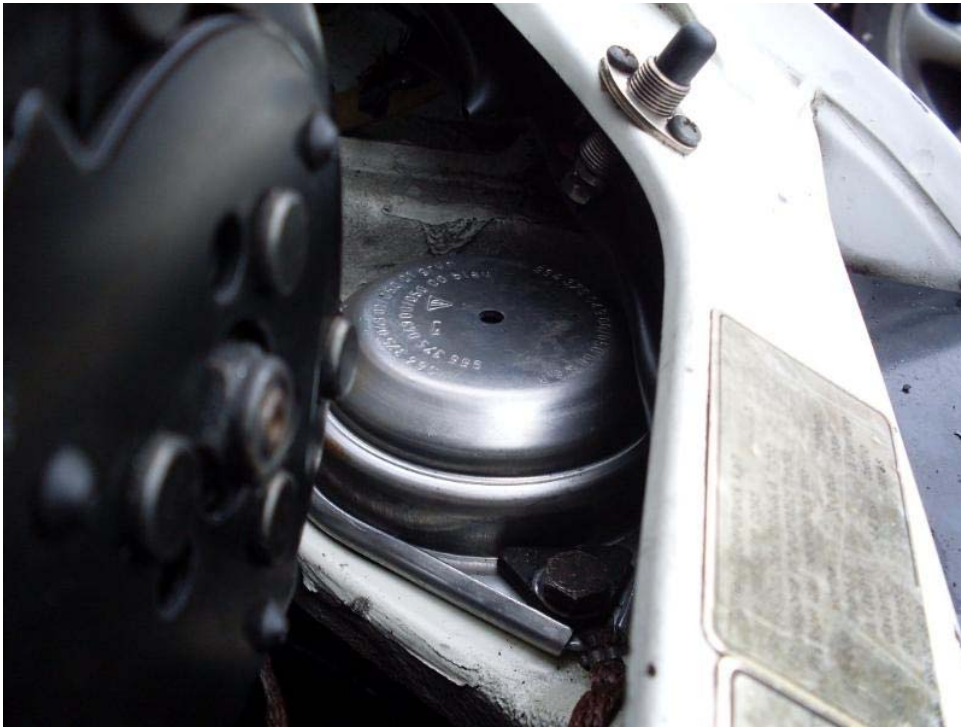
Here's the new right mount from the top:

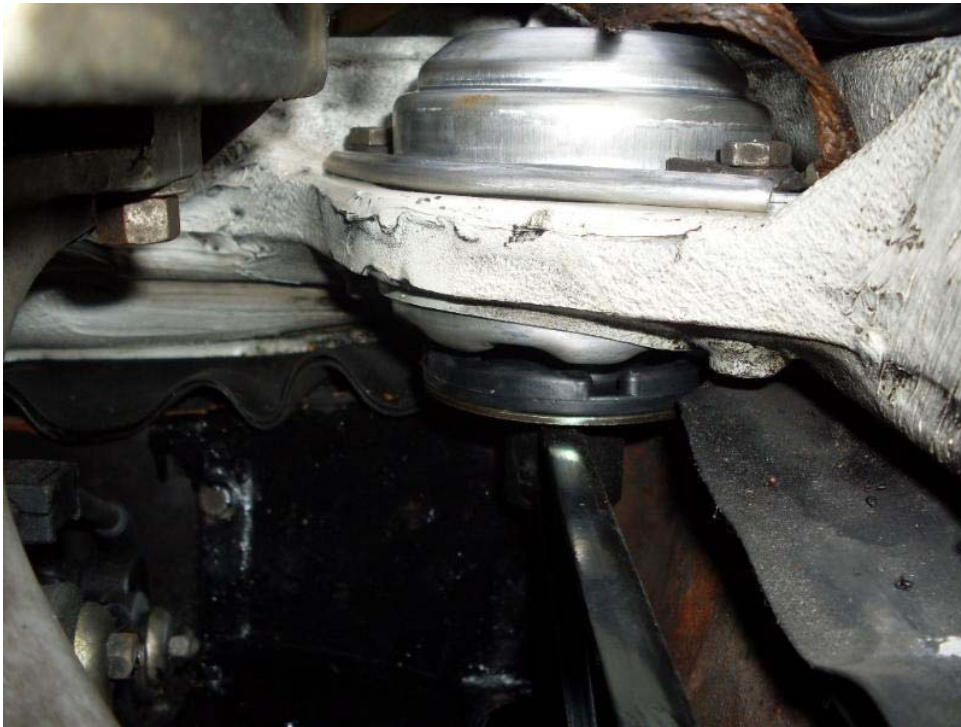
Compared to the old mounts the pictures below show there is only a small gap between the mounts and the frame.

New right mount in place:

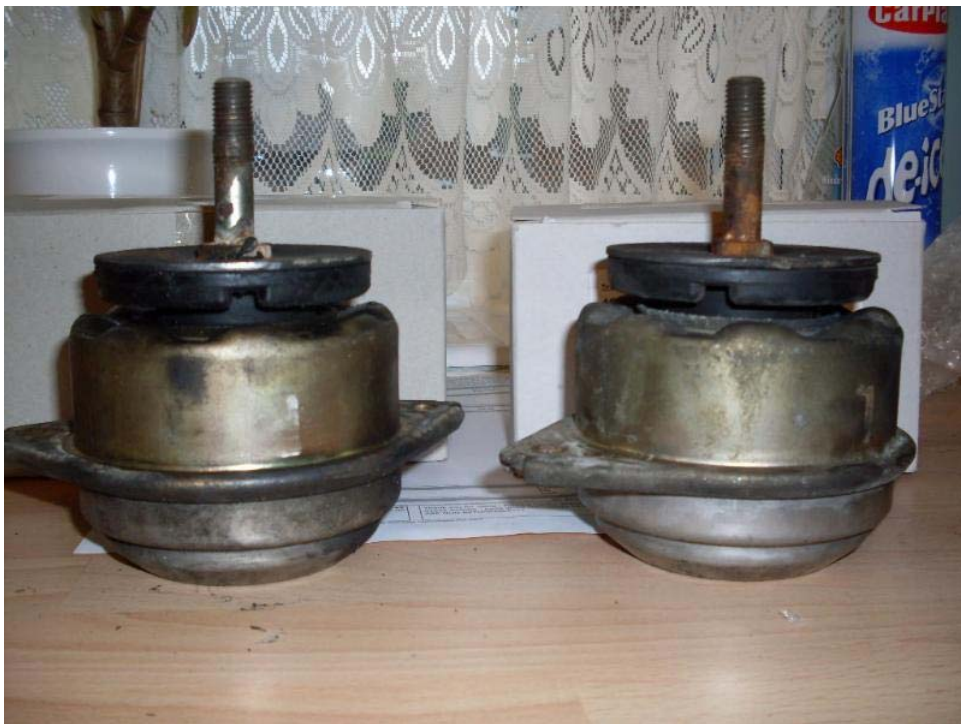
Here are the old mounts. They don't look too bad but when shaken I could hear hydraulic fluid sloshing around which indicates that they had leaked and were therefore were no longer capable of absorbing shocks transmitted from the engine:

With new mounts gear shifting is much better and the rear of the car settles much quicker when going over bumps.
